# Health Consultation

FINLAND RADAR STATION

LOOKOUT MOUNTAIN VILLAGE, LAKE COUNTY, MINNESOTA

JULY 29, 2004

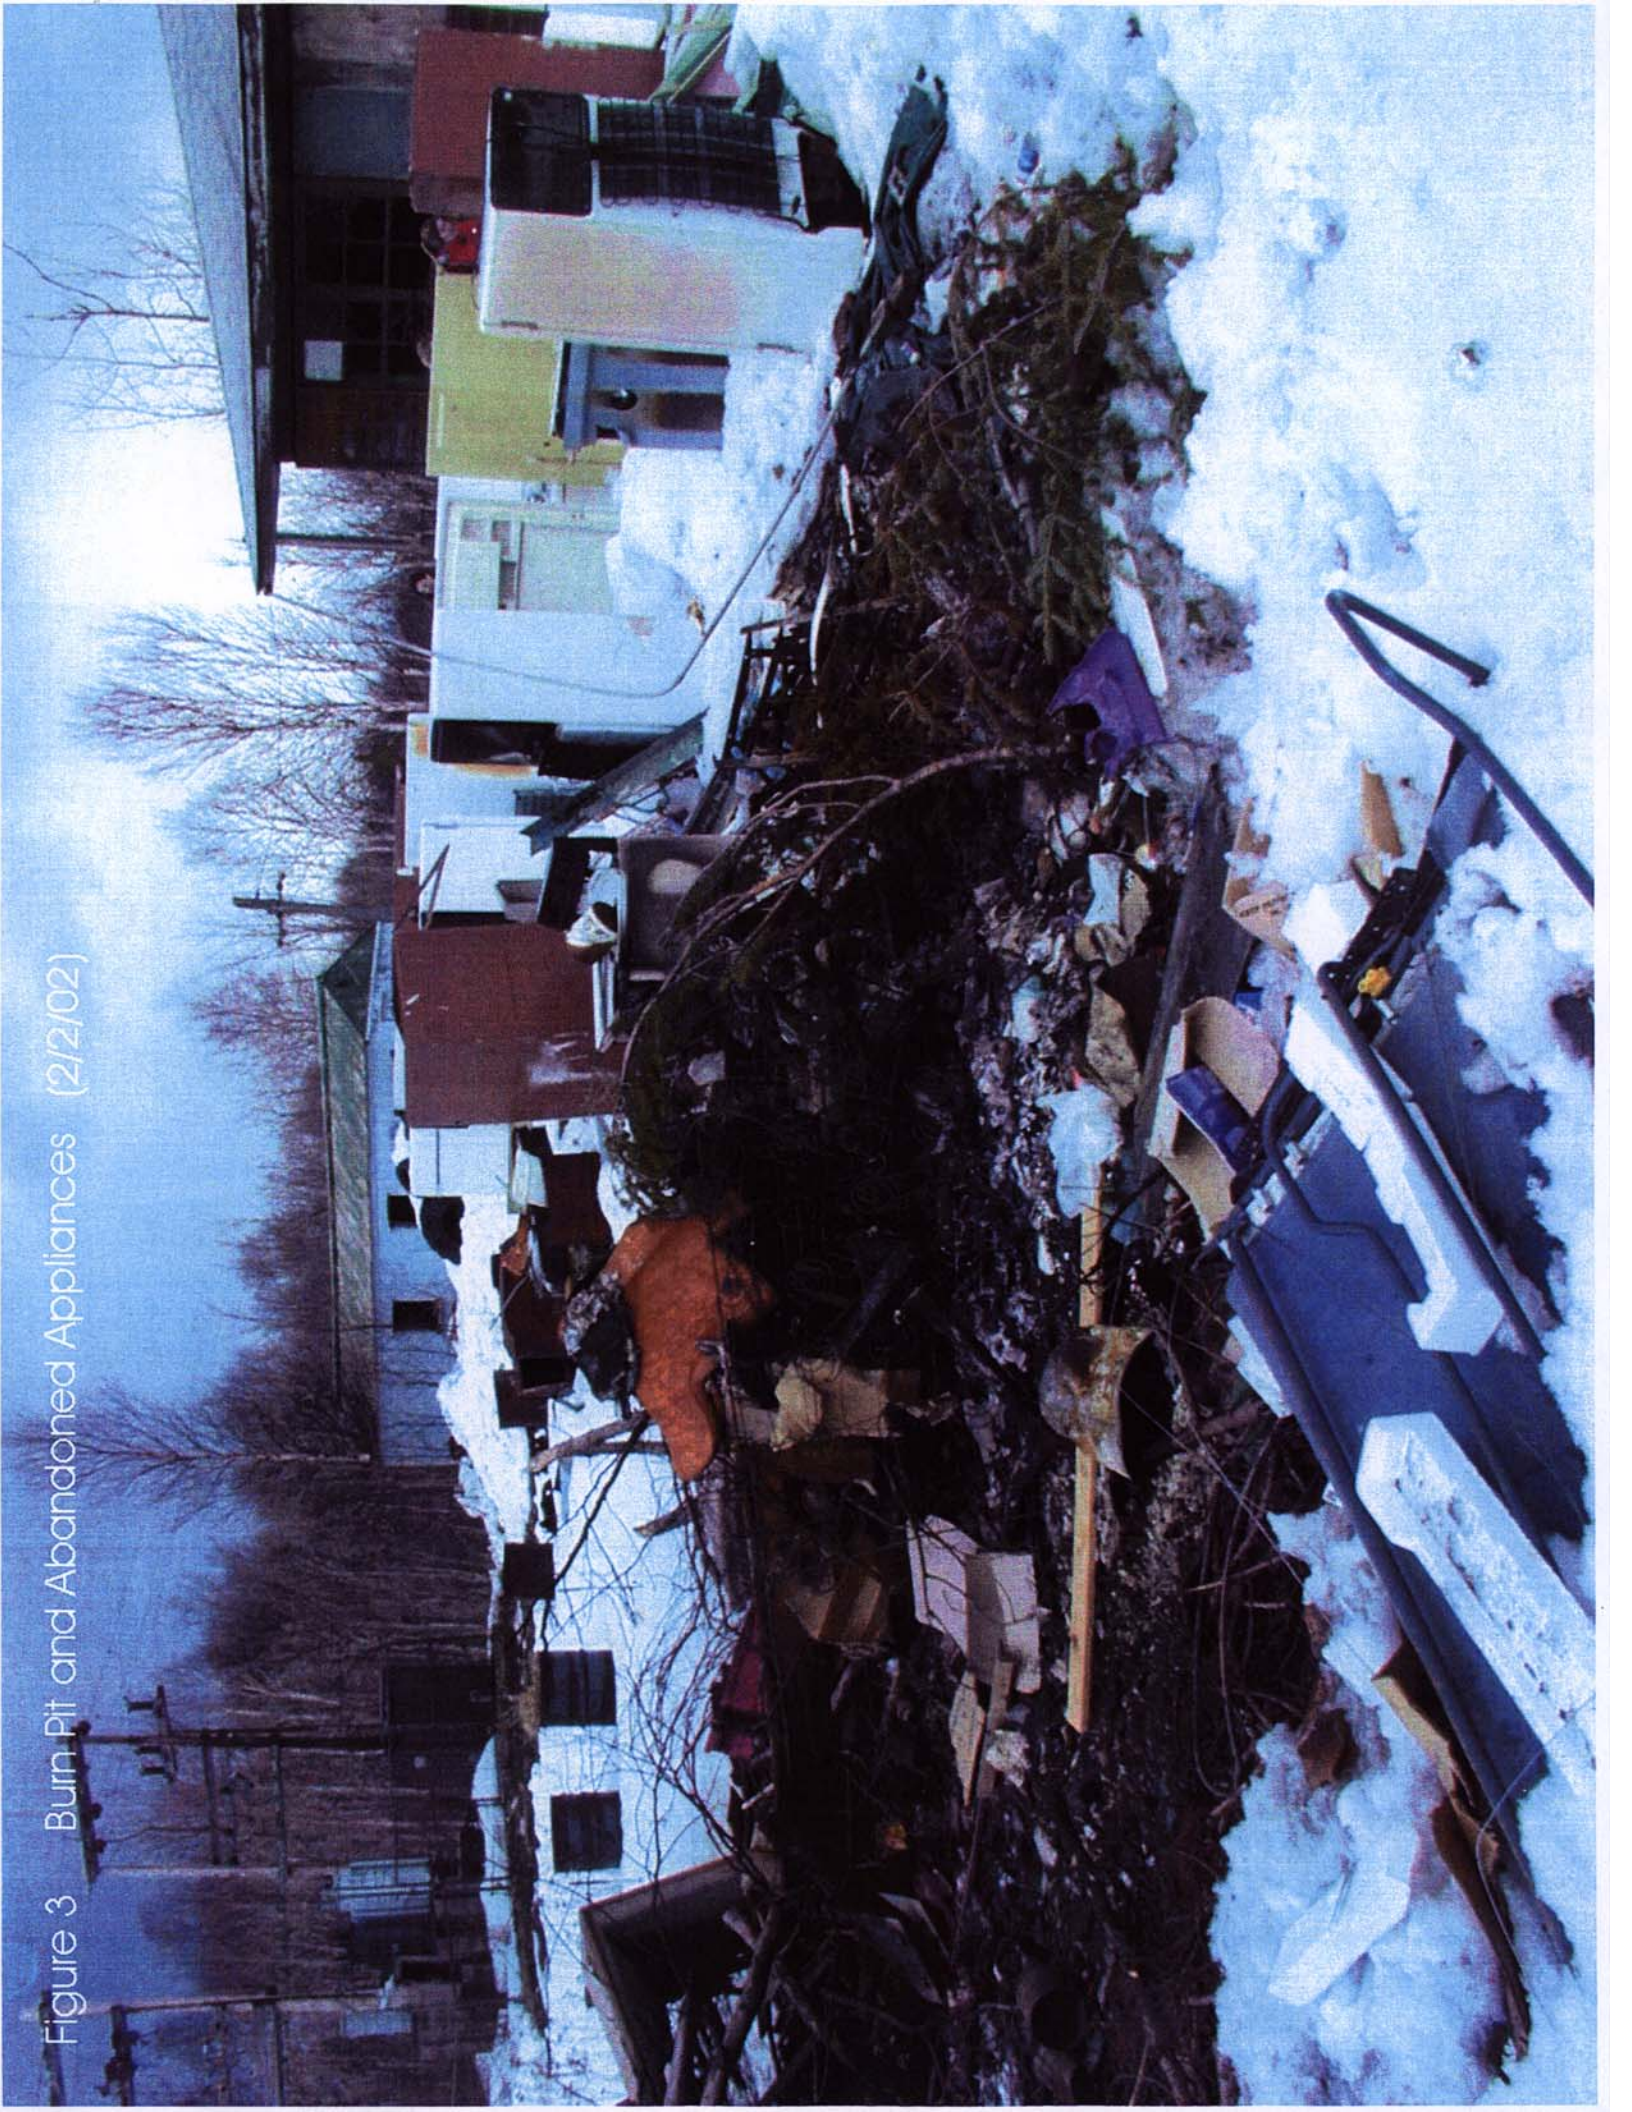
The Heating Plant room has 3 large boilers wrapped in deteriorated insulation (see glossary for a legal definition) containing suspected asbestos materials that have been pulverized. Note the amount of deterioration in the insulation from April 4, 2002, and June 5, 2003, in Figures 4, 5 and 6. The boilers contain many pounds of friable and pulverized thermal insulation. The boilers, walls, and ceiling contain large areas of deteriorated paint that is likely lead-based (see glossary for legal definitions). MDH staff tested the paint in Building 203 with a lead paint color indicator marker. The surface paint tested positive for lead. There is evidence of wind blowing materials in and out of the boiler room's missing and un-secured doors, making this building a lead source and a likely asbestos exposure hazard.

Figure 4 Building 203 (Heating Plant)  
Suspected Asbestos (April 4, 2002)

Peeling  
Lead Paint  
↓

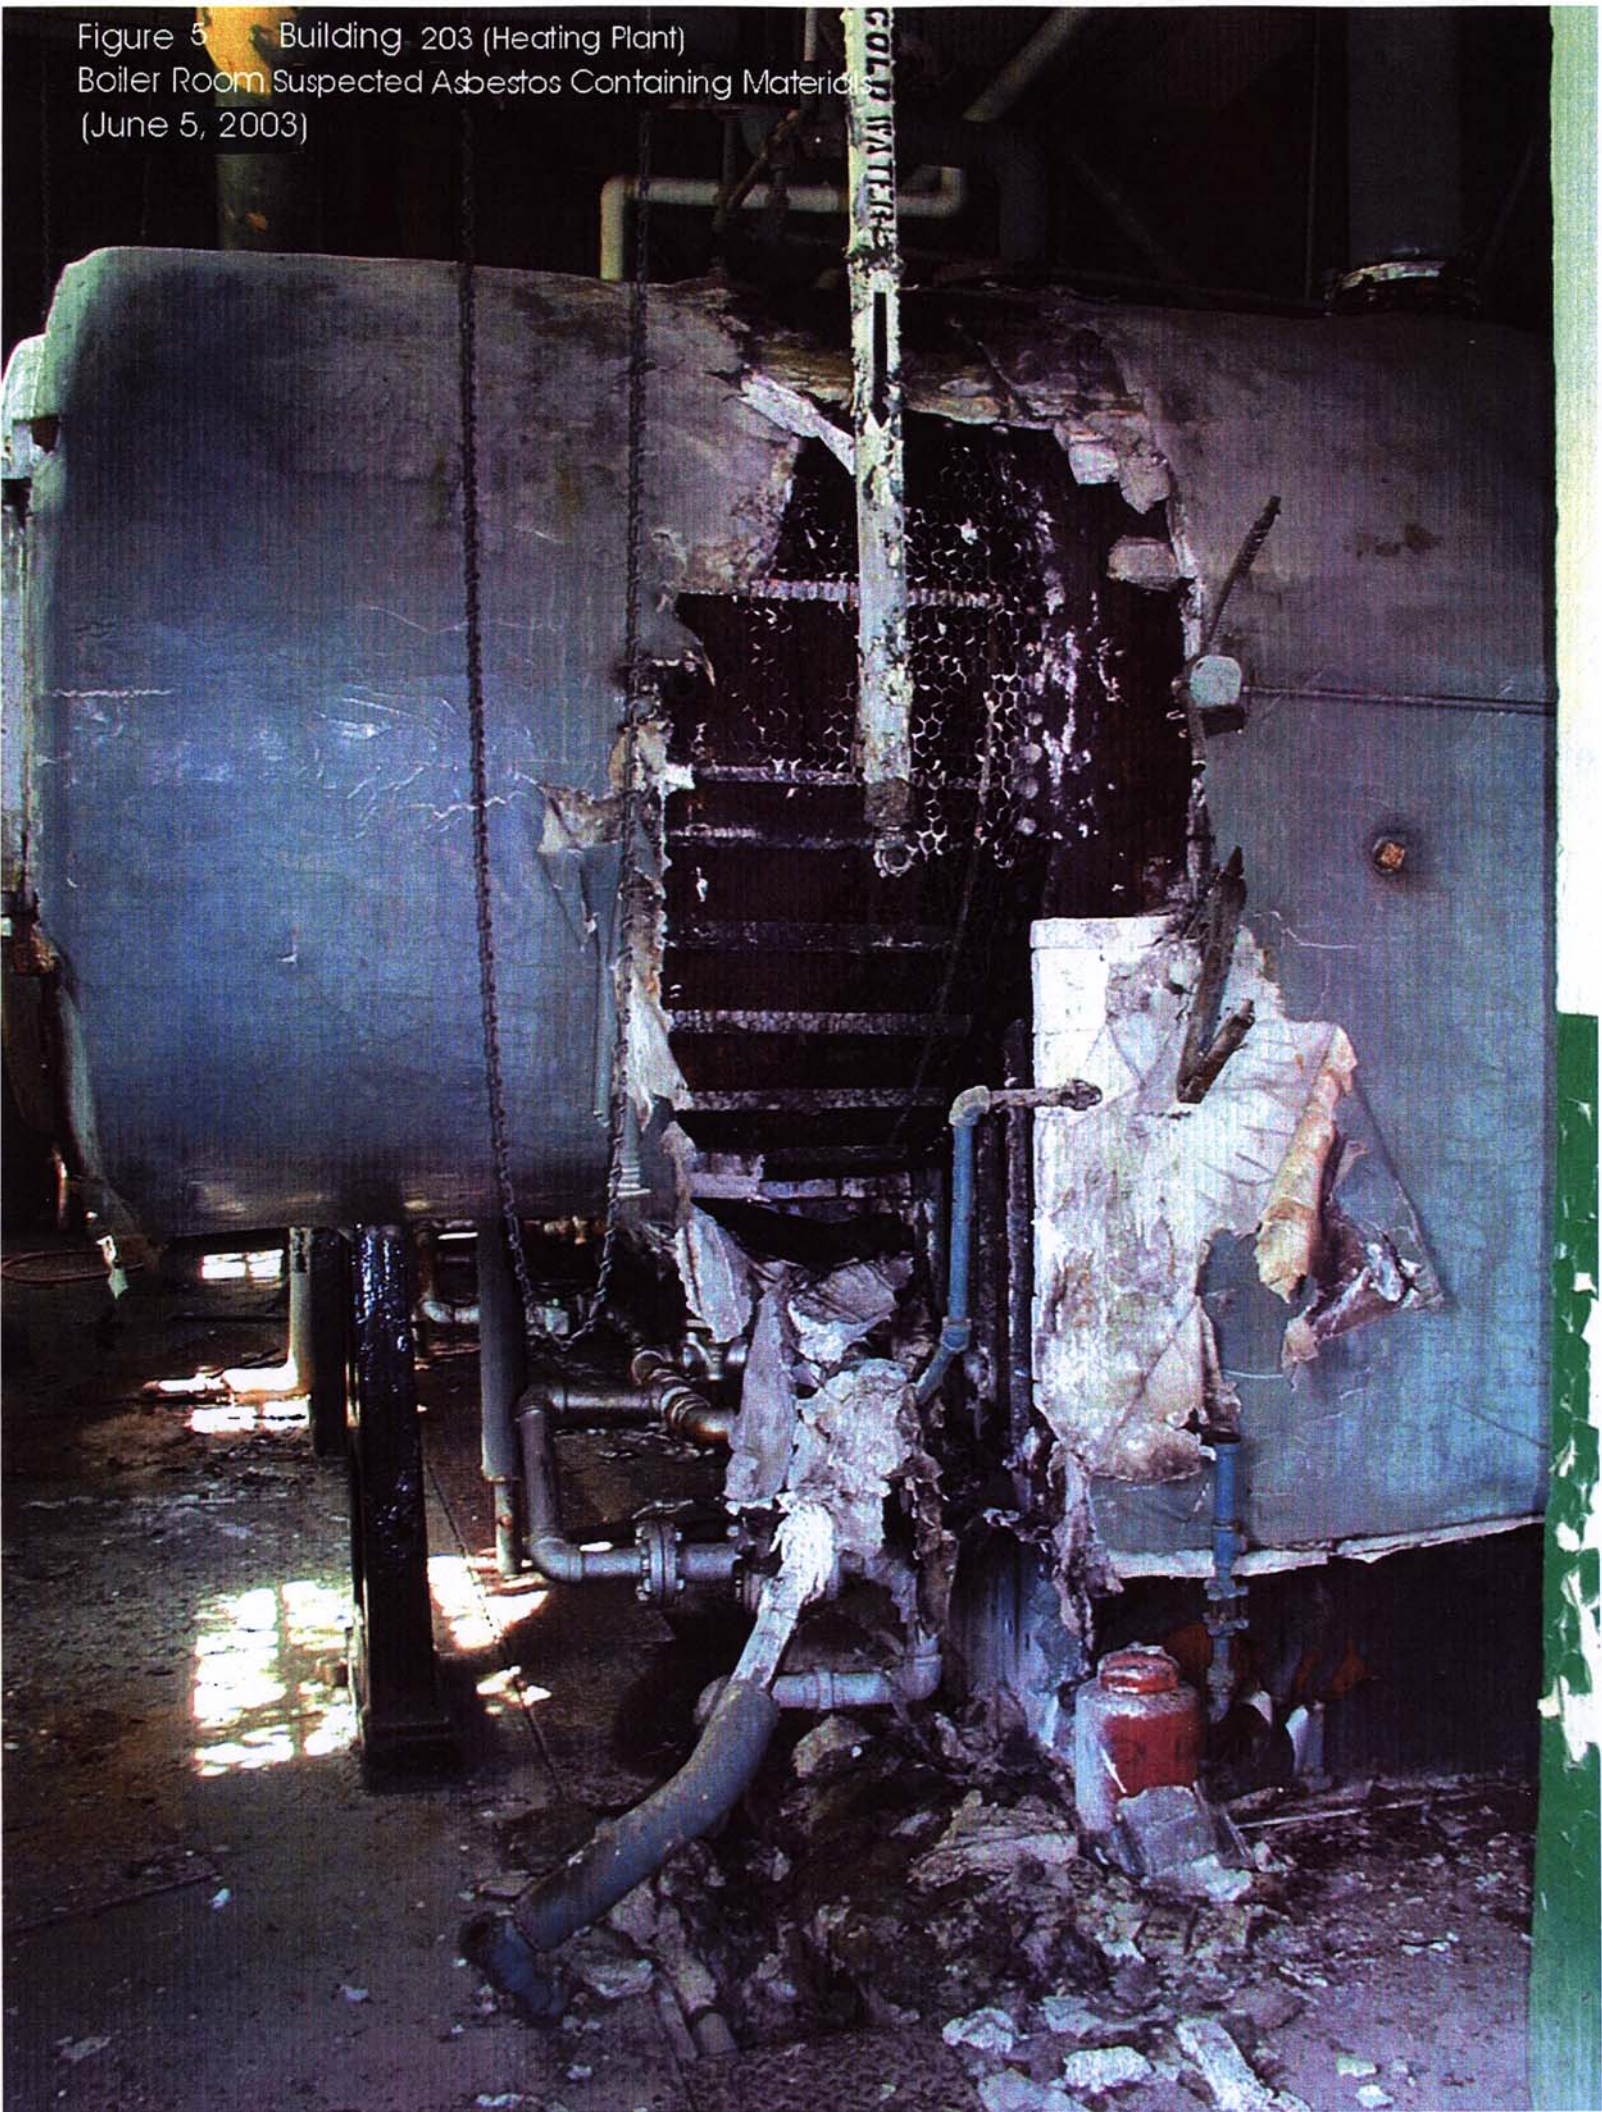
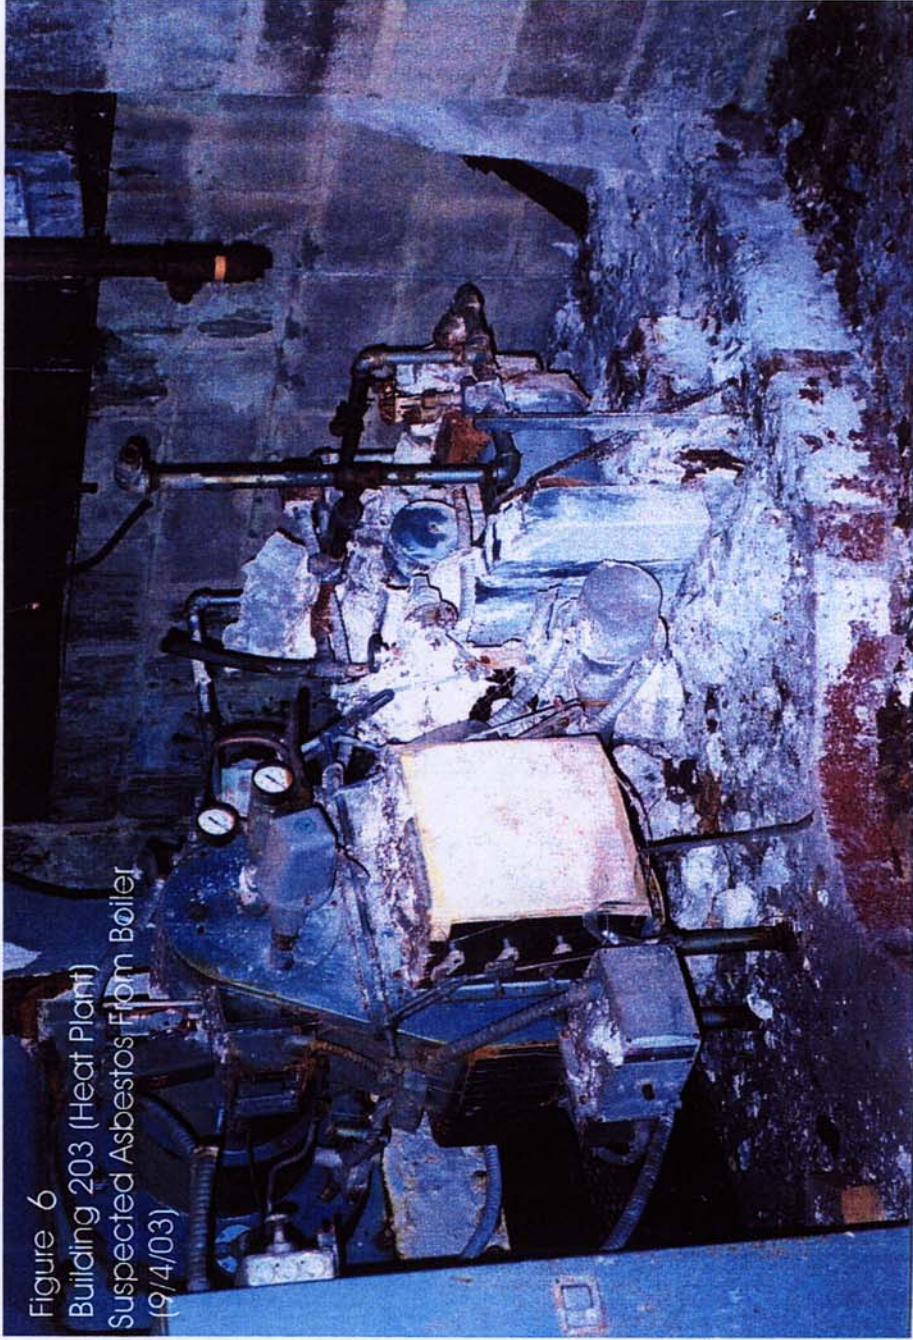
Figure 6  
Building 203 (Heat Plant)  
Suspected Asbestos From Boiler  
(9/4/03)

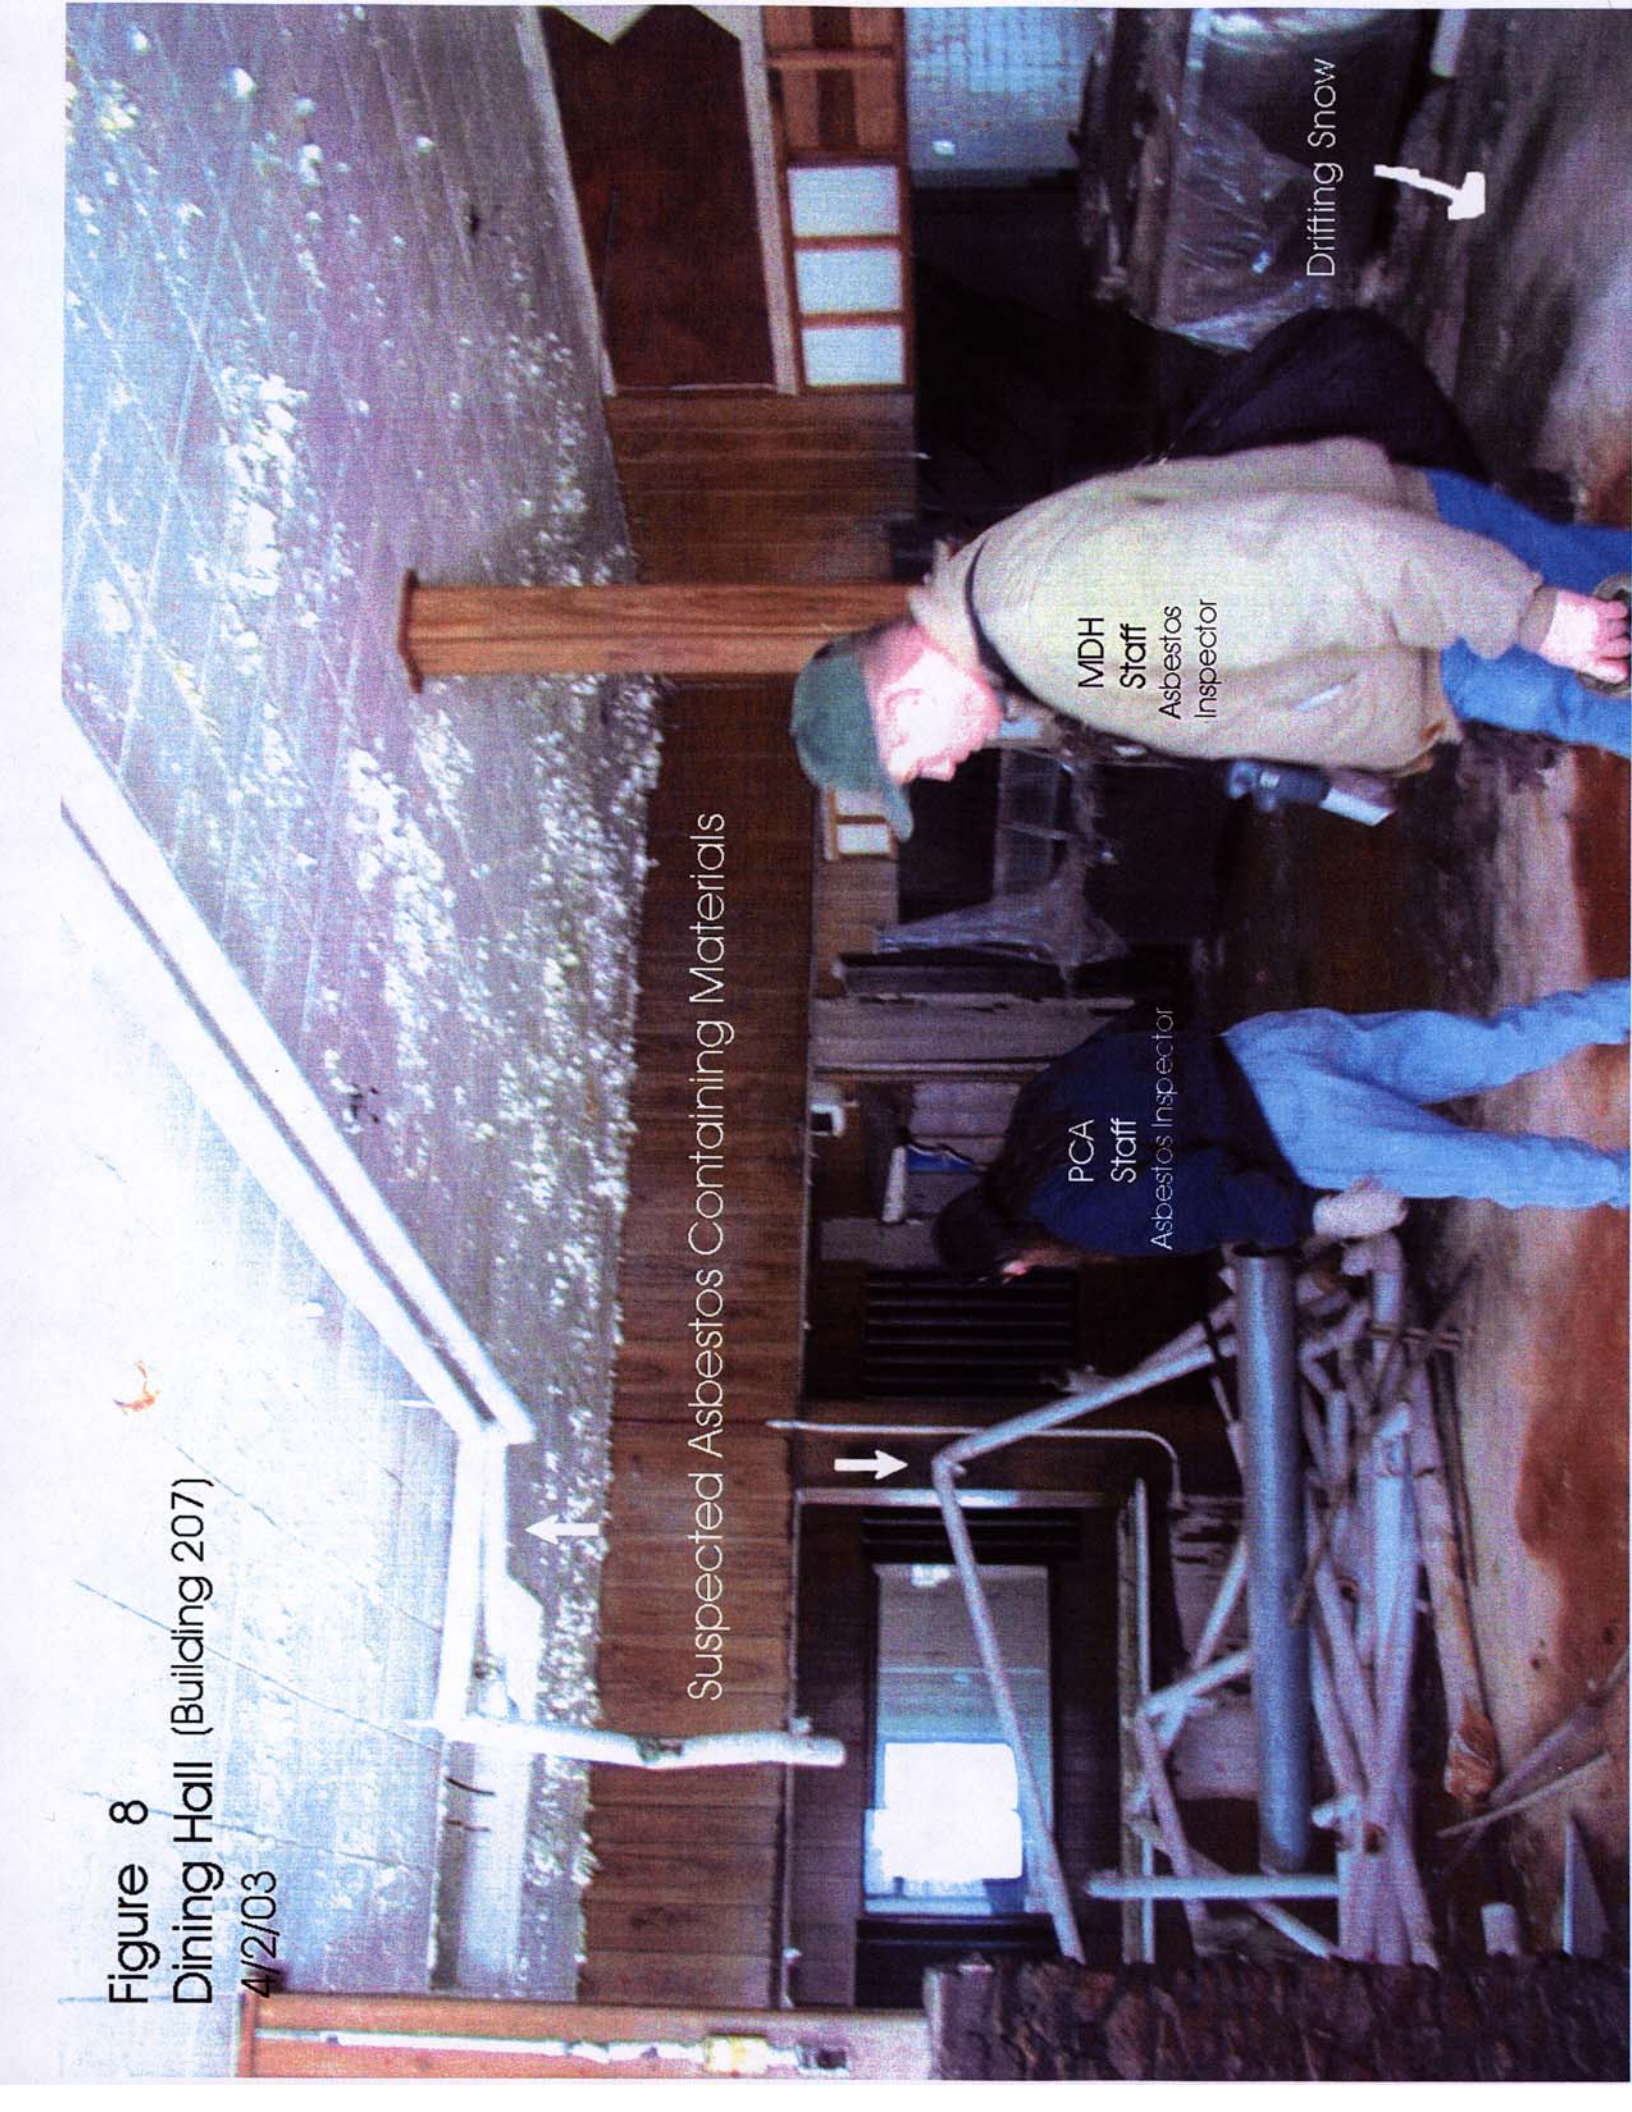
Figure 9 Building 107 (9/4/03)

Building 107 appears to be a maintenance garage for heavy machinery. It has 3 large bay doors for receiving large machinery. One of the bay doors appears to be inoperable and remains open. The cement block building is covered with peeling (suspected) lead-based paint. Several of the blocks have fallen off the dilapidated building (see figure 9). There are 3 drums with unknown contents in front of the building, and approximately 45 transformers were stored in the garage bay. Some of the transformers contained PCBs, and the floor is stained with oil leaking from several of the transformers. The building also contains suspected asbestos-containing floor tiles that are crumbling from water infiltration. Other suspected asbestos containing materials include several long runs of water damaged piping insulation found on the heating system. Building 107 is next to partially deconstructed radar domes (see figure 9).

Partially  
Deconstructed  
Radar Dome  
↓

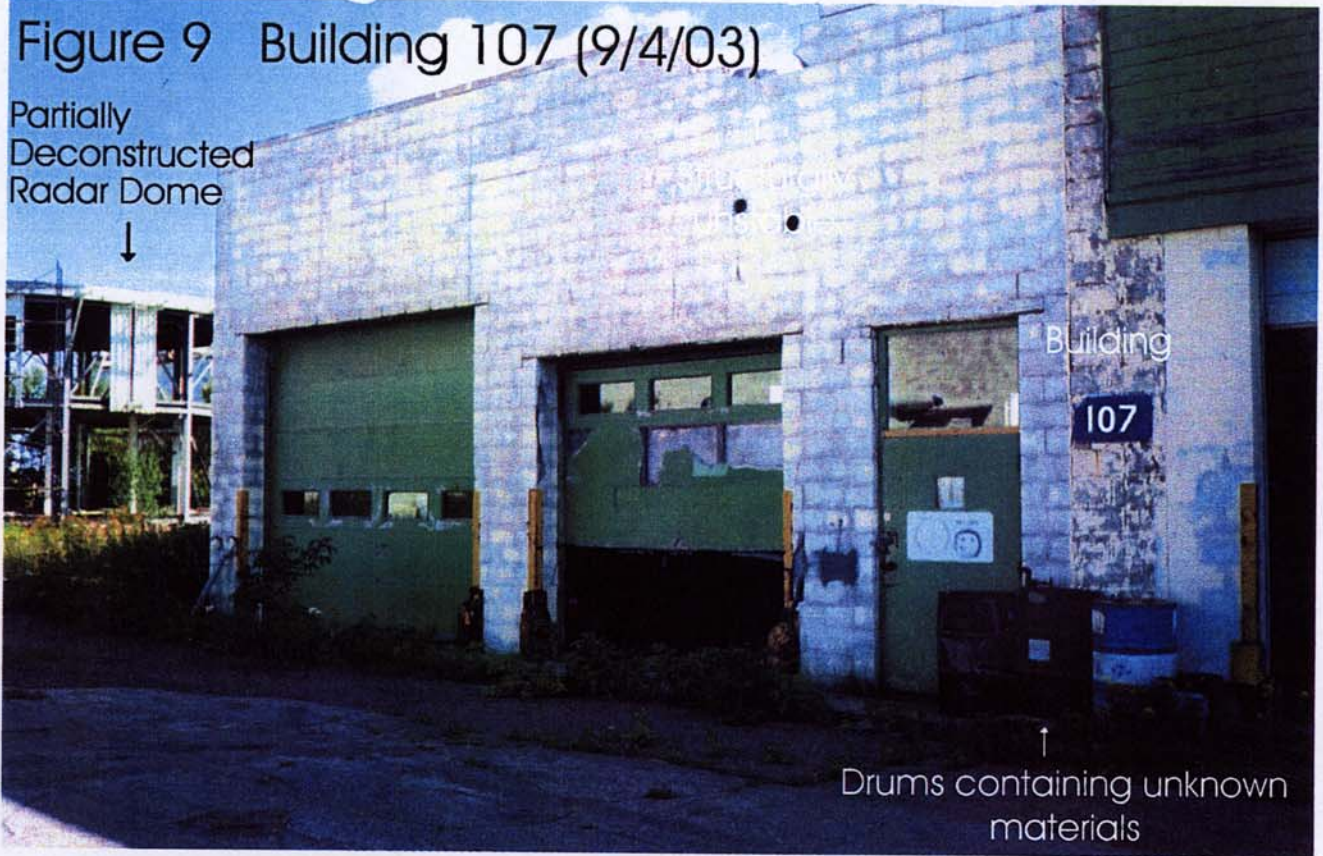
↑  
Drums containing unknown  
materials

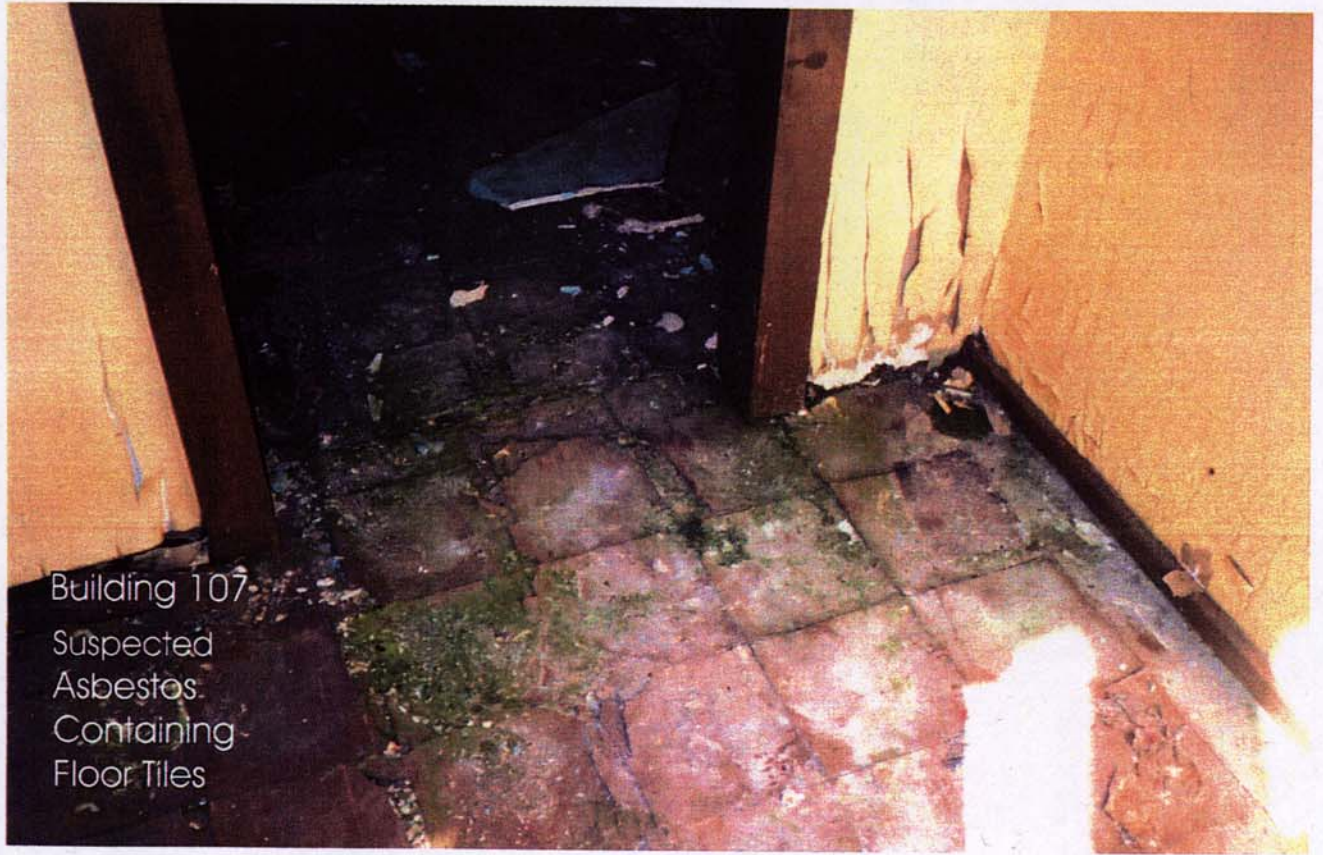
Figure 10

MDH documented the storage of 16 electrical transformers in building 107 in April 2, 2002. Subsequent testing of several transformers showed the presence of PCBs. By June 14, 2003, the number of transformers stored in building 107 increased to 46. Many of the transformers left stains on the garage floor (see figure 10). MPCA reported that 36 of the transformers contained PCB concentrations below the regulatory threshold of 50 ppm (considered non-PCB containing), and 10 transformers contained PCBs of 50-499 ppm. According to the MPCA, the 10 transformers containing PCBs greater than 50 ppm were sent to a hazardous waste facility by Cooperative Light and Power staff. Cooperative Light and Power shipped the remaining 36 transformers to B & B Transformers Inc for disposal. According to MPCA, Cooperative Light and Power has agreed to clean the PCB stains on the garage floor. Because the transformers were stored in various locations in the garage, the MPCA has recommended that the whole floor be cleaned. Many of the buildings on site have very old fluorescent light ballast that may contain PCBs.

Building 107  
Suspected  
Asbestos  
Containing  
Floor Tiles

Building 107  
PCB Leaking Transformers  
(6/14/03)

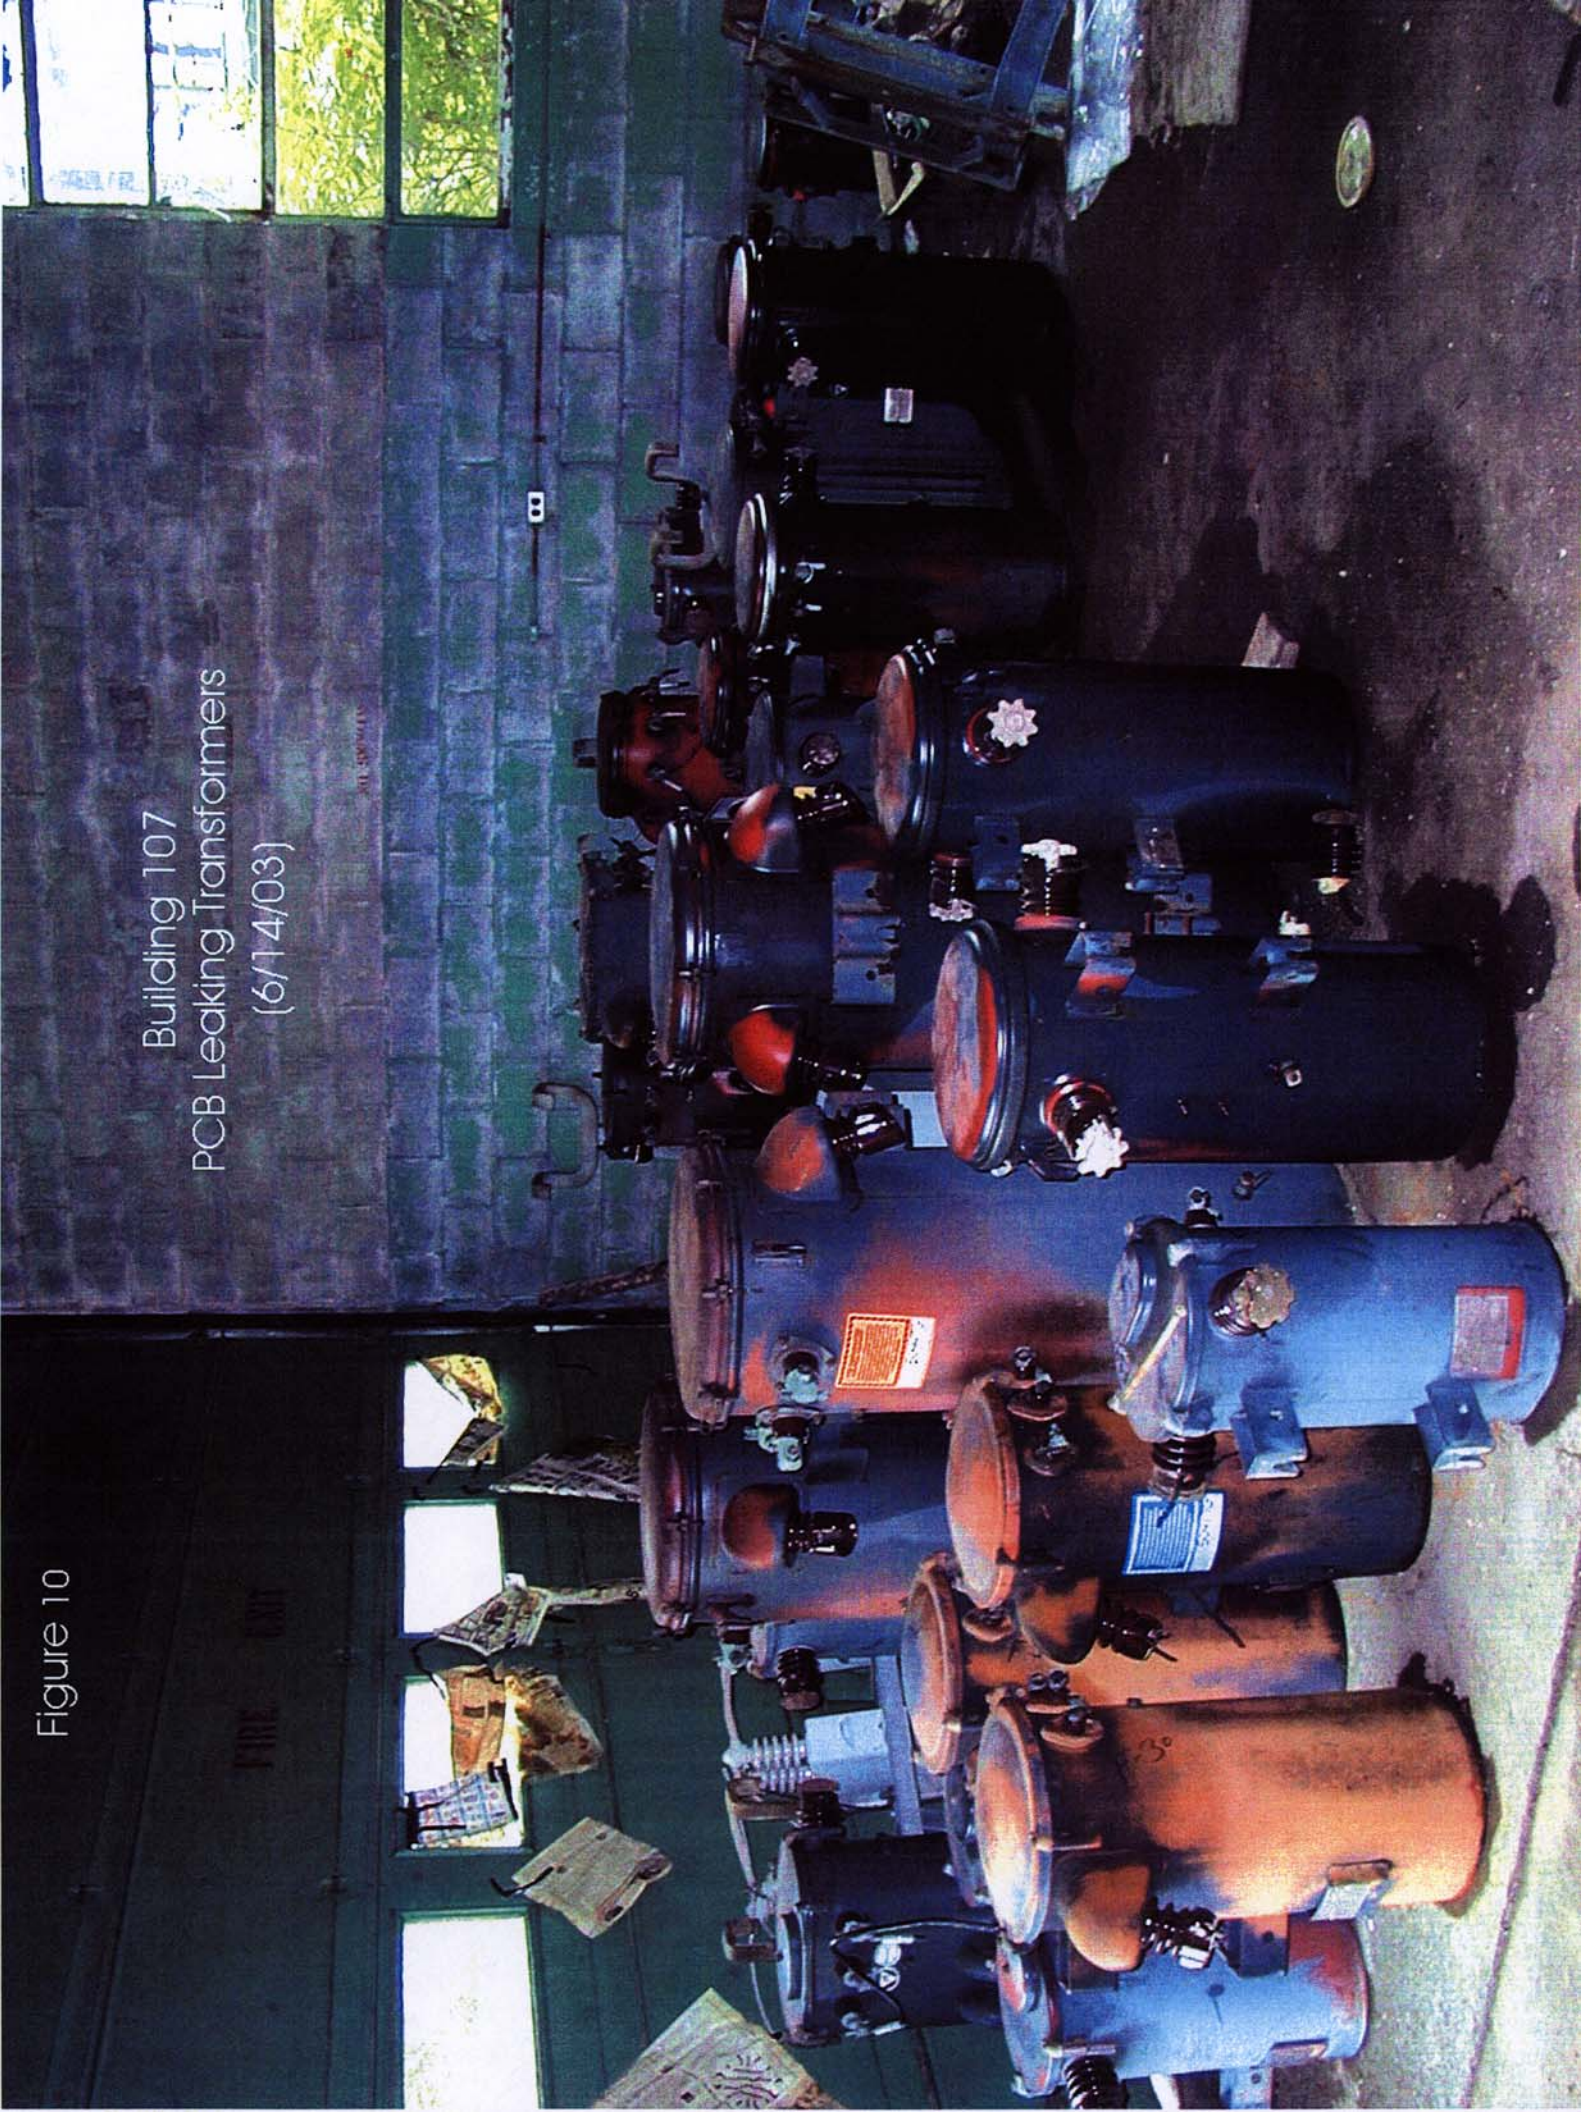
Building 303 was a multi-purpose building originally used for recreational activities. A smoked fish business most recently occupied building 303. The company sold smoked fish to the public. MDH has documented the dumping of partially burned fish carcasses and piles of trash scattered outside the building (see figure 11). Also located outside the building were abandoned vehicles and a dumpster filled with water-logged fish carcasses. The Minnesota Department of Agriculture cancelled the facility's permit in the summer of 2003. The trash and abandoned vehicles were removed in response to a MPCA warning for violation of solid waste management rules. On December 4, 2003, MDH and the MPCA observed the continued operation of the fish smoking business after the license had been cancelled.

Figure 11  
Building 303  
Smoked Fish Business

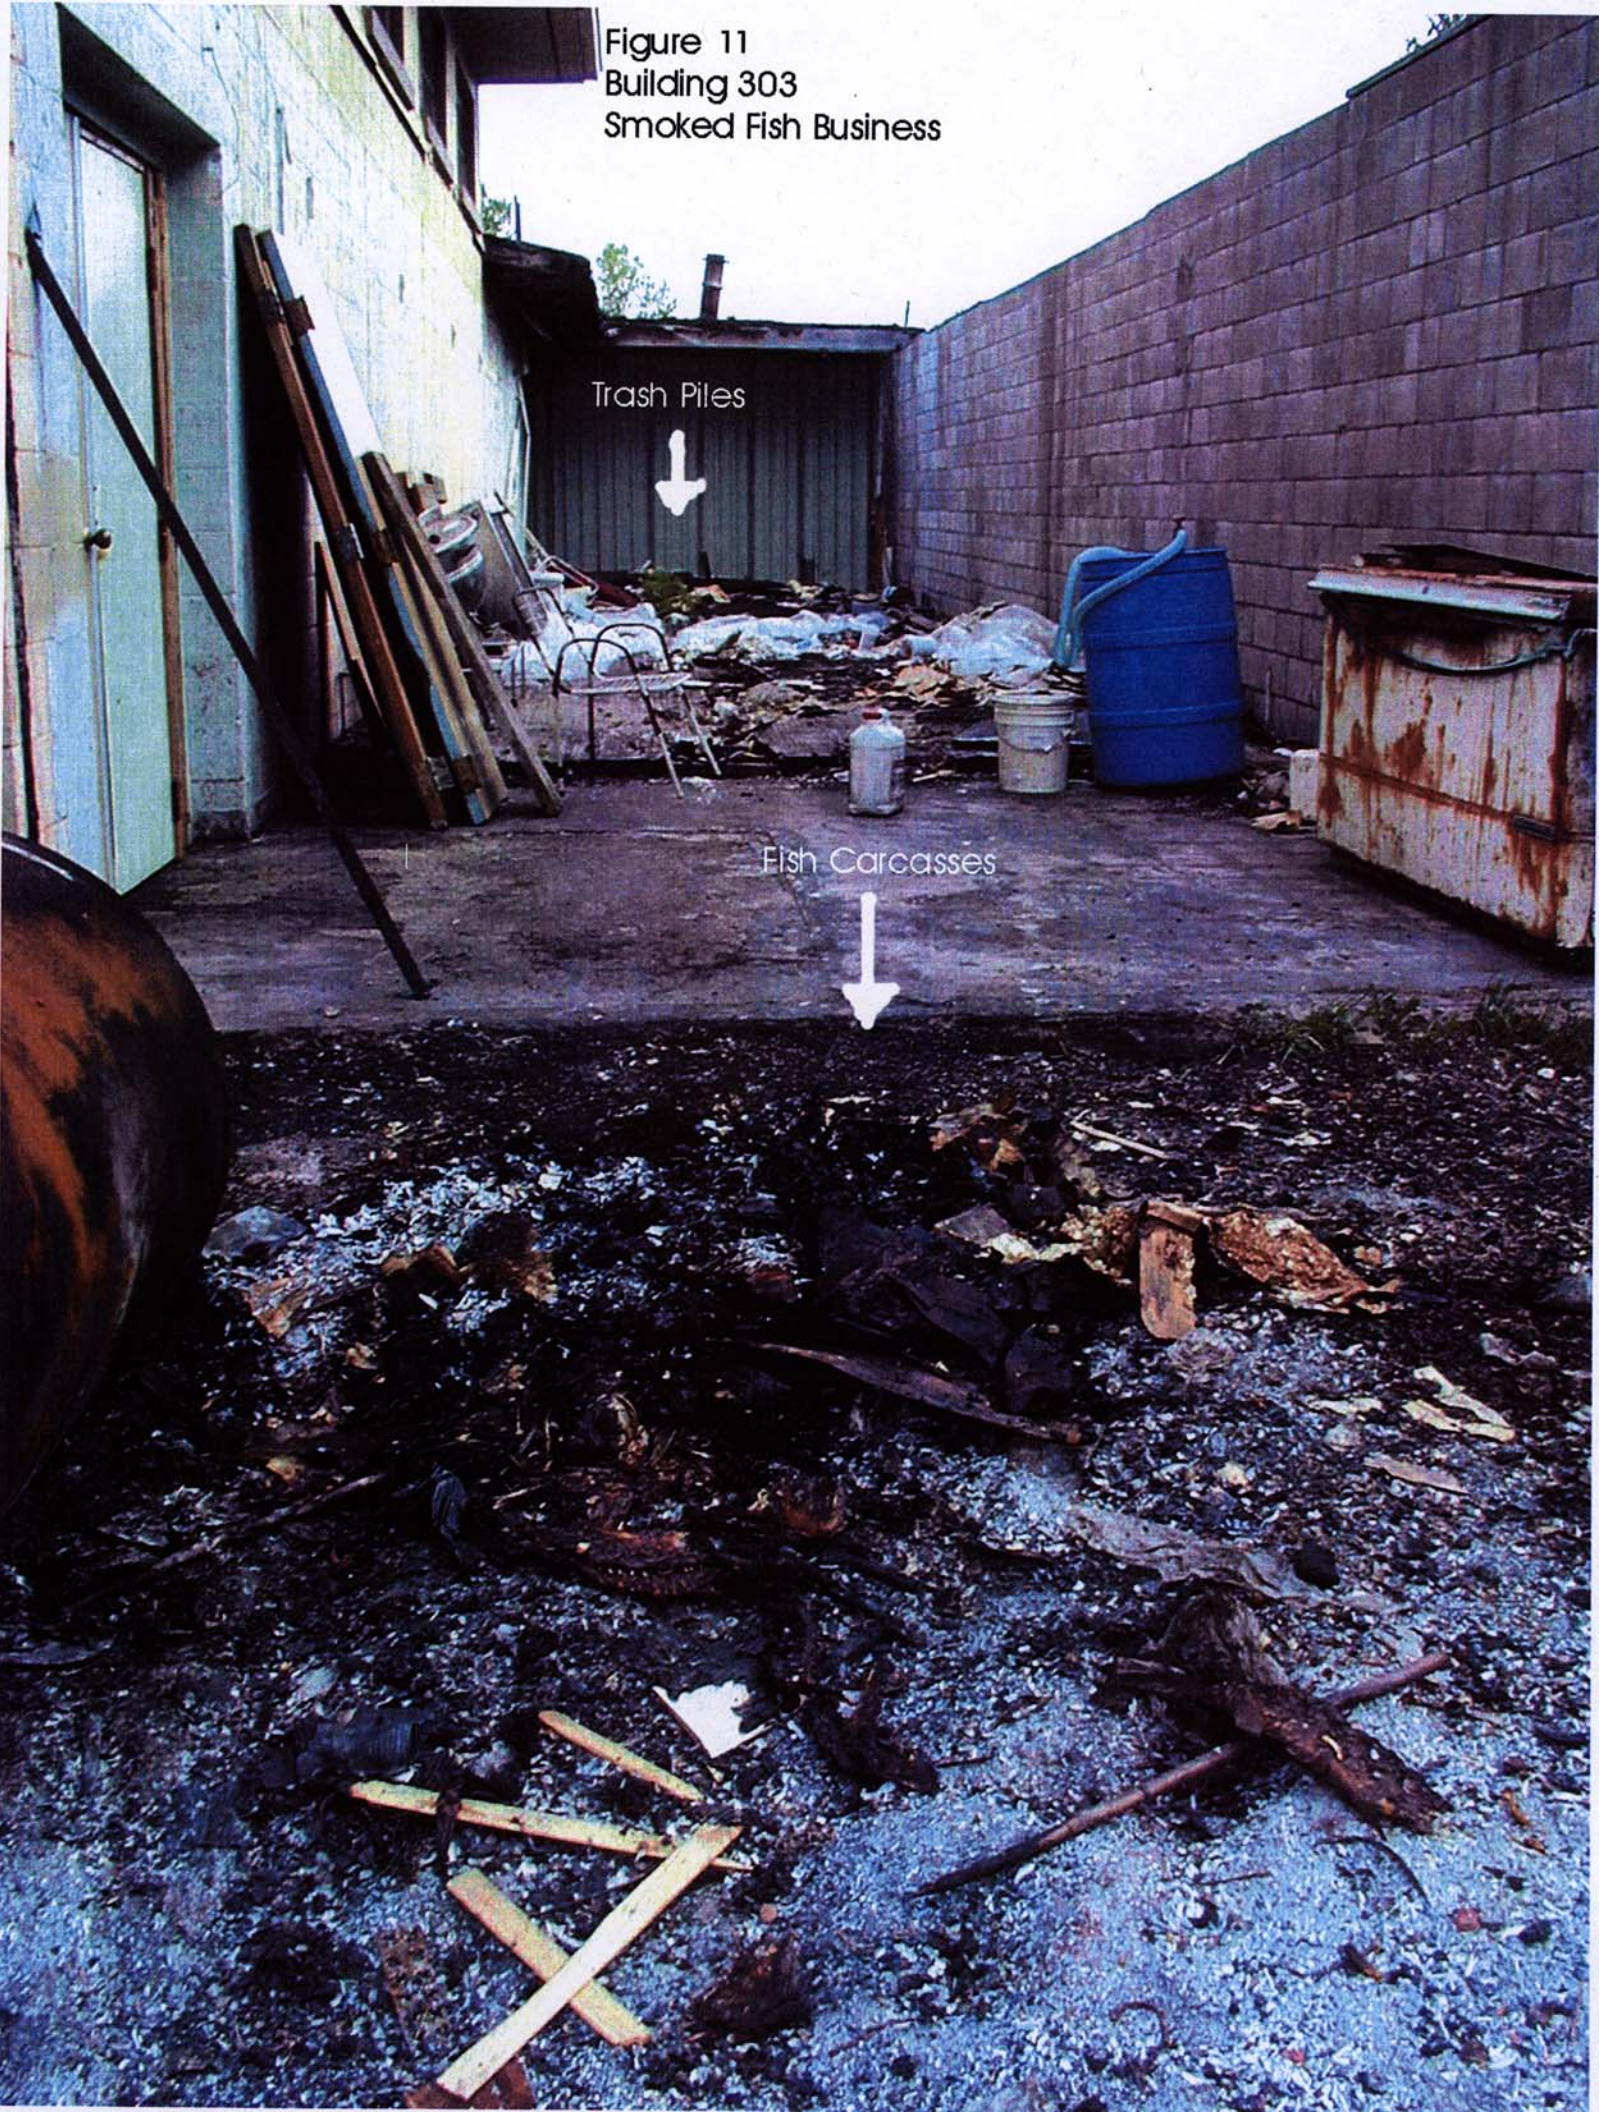
Trash Piles

Fish Carcasses
