# Health Consultation

FINLAND RADAR STATION

LOOKOUT MOUNTAIN VILLAGE, LAKE COUNTY, MINNESOTA

JULY 29, 2004

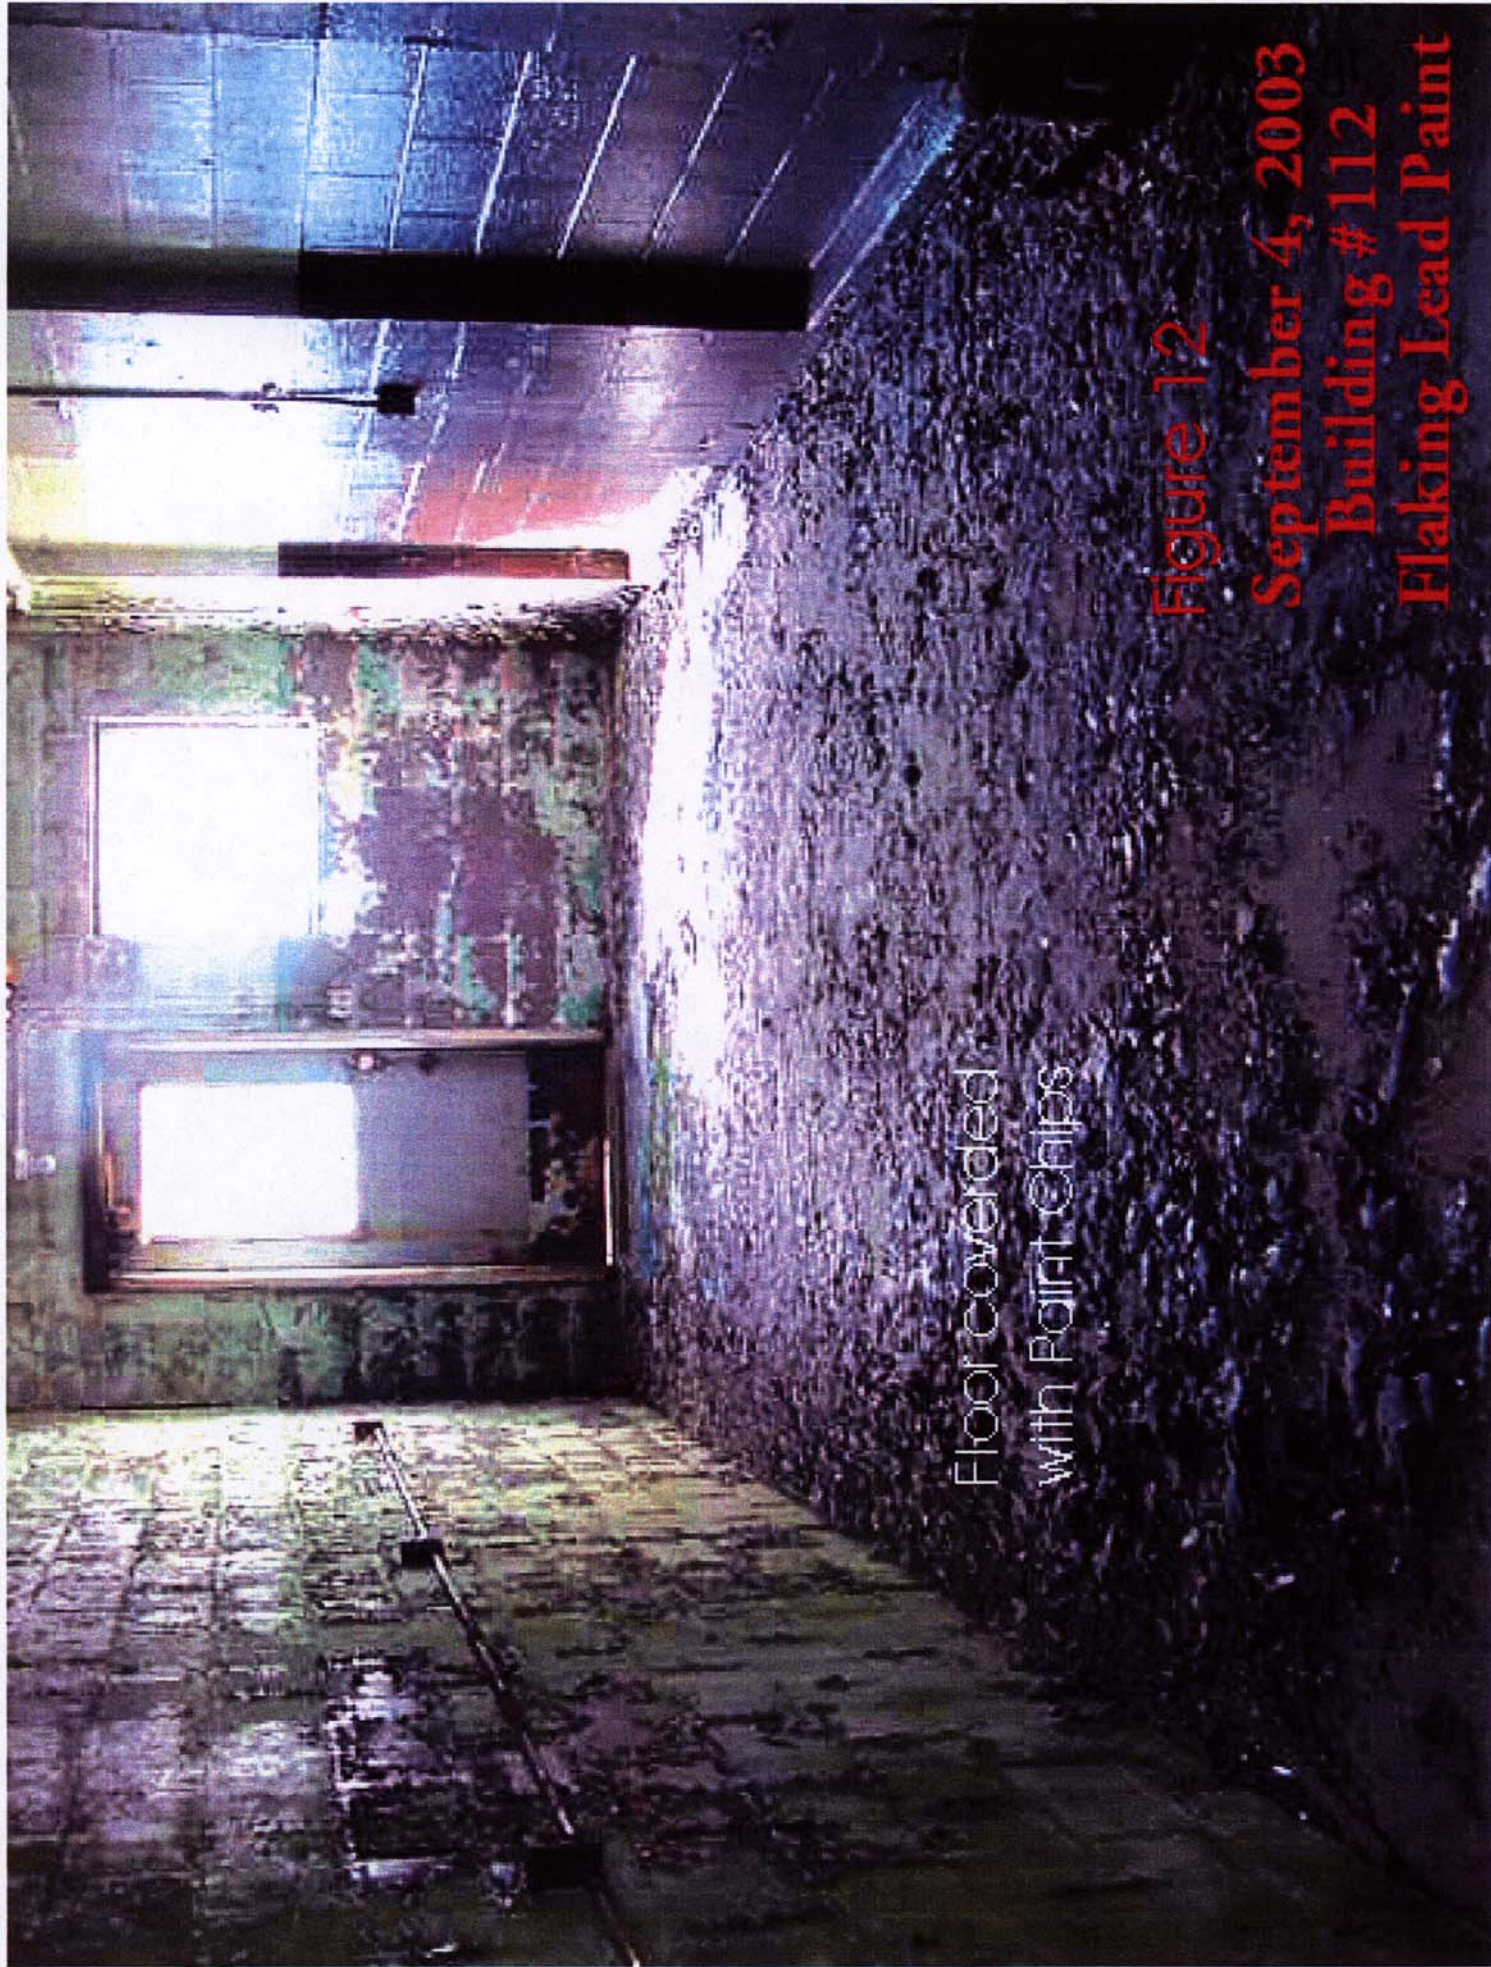
Figure 12

During a site visit on September 4, 2003, the MPCA collected 10 samples in building 112 for asbestos analysis. Table 1 lists the sample materials and their asbestos content. Several of the samples tested positive for chrysotile, and amosite. Asbestos-containing materials in building 112 were significantly deteriorated and friable (see glossary for legal definitions). Building 112 contains pounds of peeling paint that have accumulated on the floor (See Figure 12). The MPCA collected four paint chips in building 112, which MDH analyzed for lead. The paint chips lead content ranged from 0.3 – 1.2 percent by weight.

Floor covered  
with Paint Chips

September 4, 2003  
Building #112  
Flaking Lead Paint

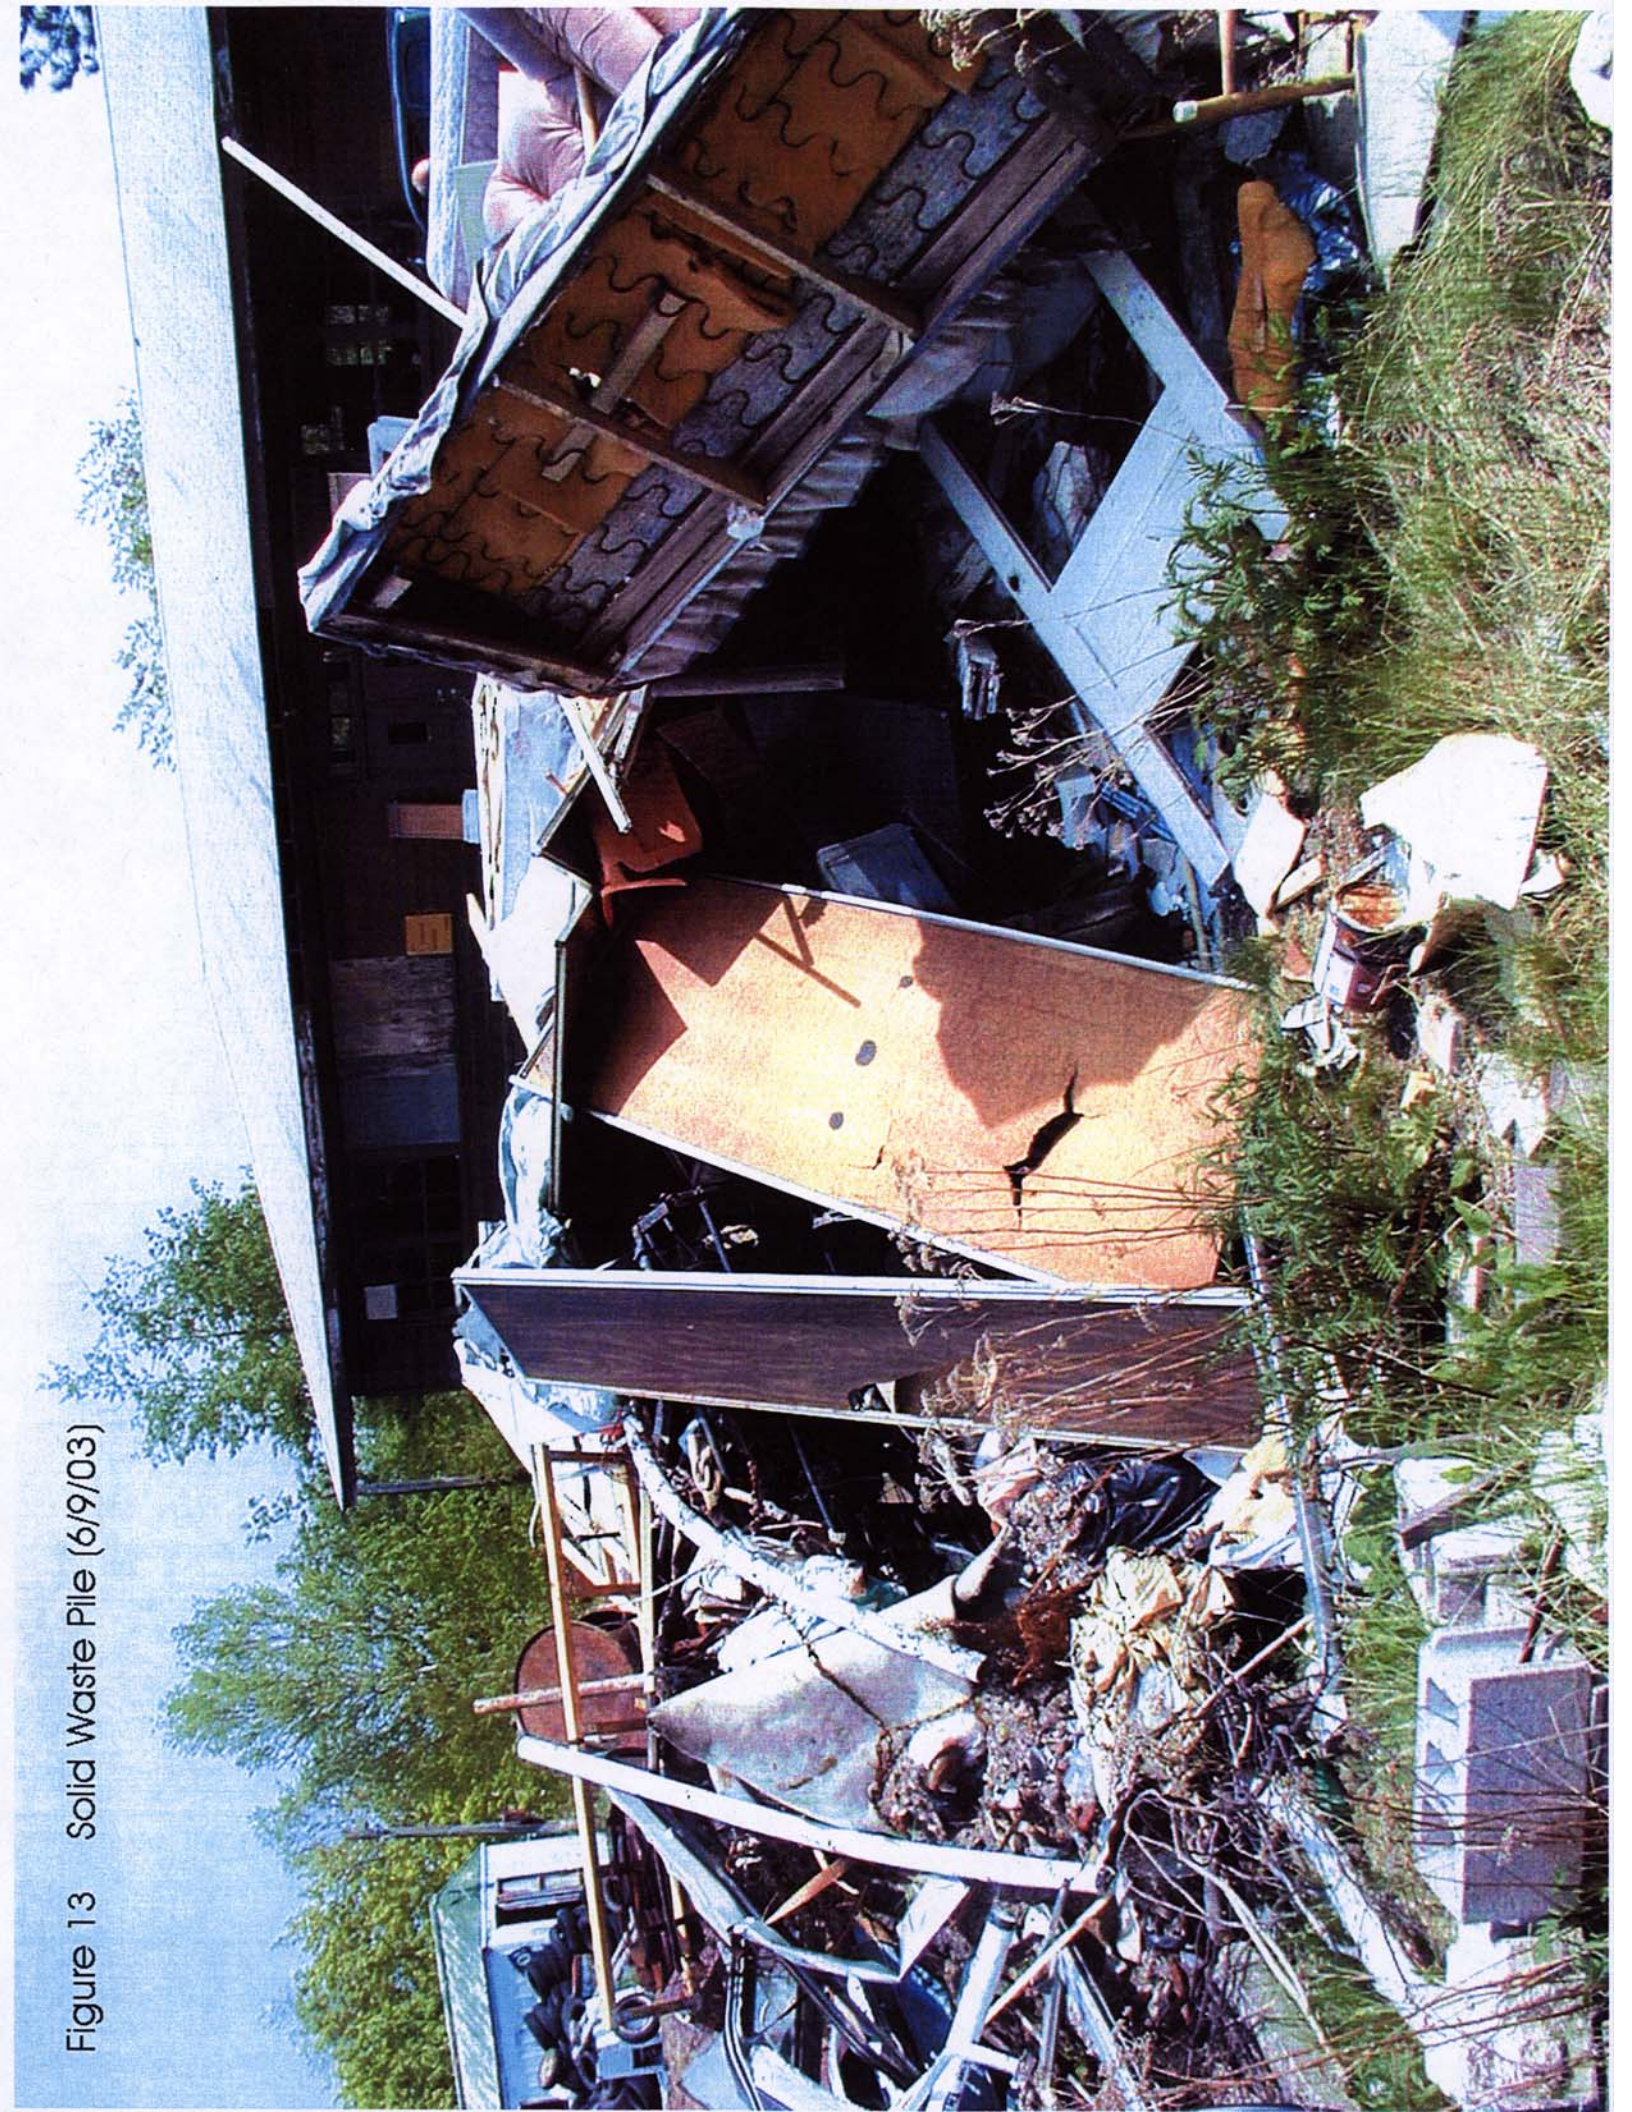
It is not uncommon to find scattered trash piles throughout the site consisting of general refuse, appliances, and other solid waste (see Figure 13). There is a history of burning trash at the site as recently as 2002 (MDH 2002). The Minnesota Pollution Control Agency (MPCA) issued a letter of warning to Lookout Mountain Village management (Finlandia LLC/Juno Investments) on June 11, 2003 for violations of Minnesota Solid Waste Rules 7035 (1). Finlandia management paid for the removal of several dozen cubic yards of solid waste and approximately 100 tires from the property in July 2003. Several of the buildings on site are piled with solid waste, and the accumulation and mismanagement of solid waste at the site has been a continuing problem.

Figure 13 Solid Waste Pile (6/19/03)
